Monitoring Report South Fork of Quitchupah

We were able to access the South Fork of Quitchupah on May 19th. The length of the creek below the road to the confluence of the North and South Fork was surveyed. The approximate flow above the road was 192 gpm, in the deep canyon below monitoring point 006 C the flow was estimated at 40 gpm. On May 23 the repair of the cracks was observed to be holding with the uninterrupted flow being estimated at 150 +/- at the road crossing and below monitoring point 006C. On May 27, Joe Helfrich and mine personnel observed the flow in the South Fork to be uninterrupted from the road crossing to the confluence. The flow in the creek above the road was measured at approximately 300 gpm on May 29, similar flow was observed from above Spring 006A to the confluence of the South and North Forks of Quitchupah. Flow appears to fluctuate during the day, likely due to snow melt from higher elevations and the potential for diversion of water at the top of South Fork.

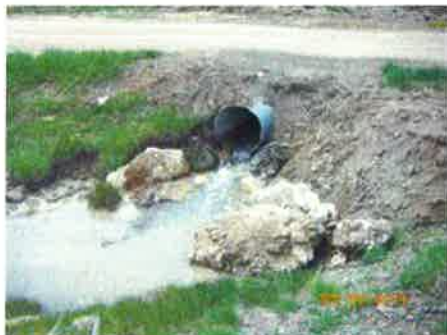
IMGP2822.JPG
1845K

It rained on the 23rd, 25th, 29th and 30th. Photos 2839, 2759 and 2765 depict flow in creek below the location of crack repair. Photo 2822 is flow above the crack repair.
